Manhole Inspection Summary

Manhole # S31AA2015MH

Location Address: **103 NORTHERN PKWY**

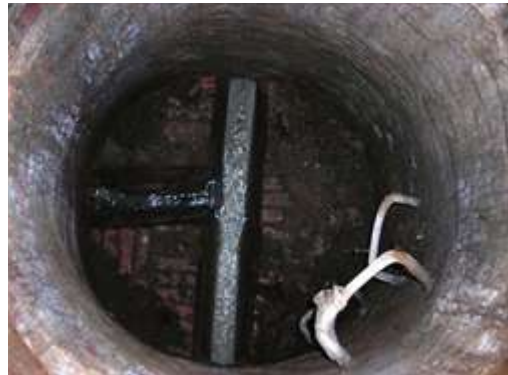
Top View

Evidence of surcharge - Bench debris.

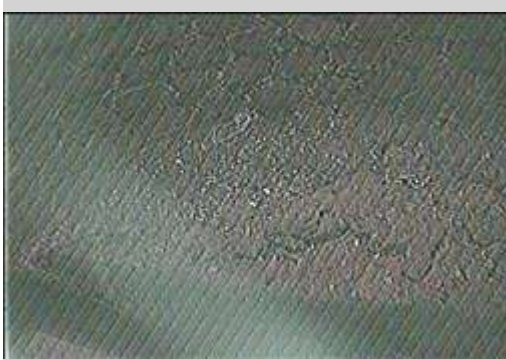
Defect

Barrel deterioration and infiltration.

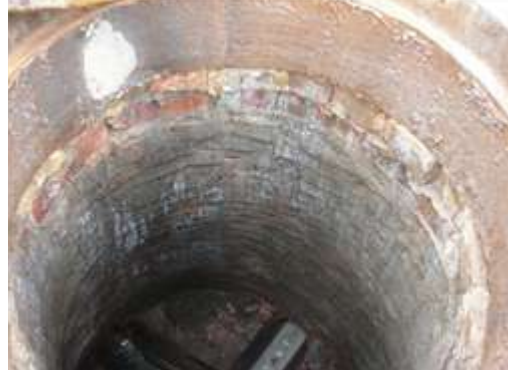
Defect

Frame leaks. Adjustment deterioration and infiltration.

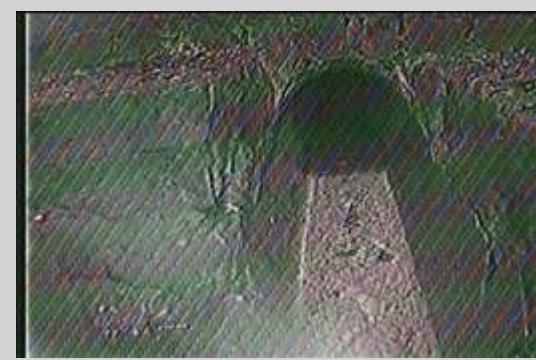
8 in. Circular Gravity Sewer Pipe Out @ 12 O'Clock

Infiltration: **Evidence** Pipe Seal Cond: **Cracked**

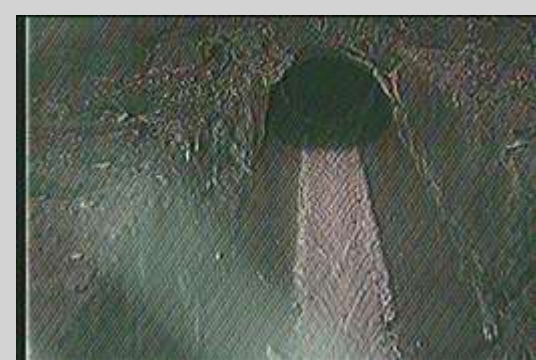
8 in. Circular Gravity Sewer Pipe In @ 6 O'Clock

Infiltration: **None** Pipe Seal Cond: **Broken**

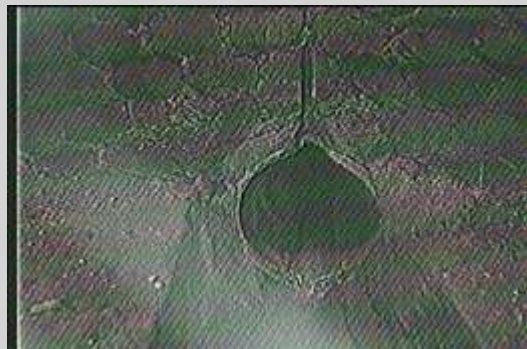
Pipe In @ 9 O'Clock

Pipe Seal Cond: **Broken**
